**Piotr STRZAŁKOWSKI<sup>1</sup>**

**THE IMPACT OF MINING AND GEOTECHNICAL FACTORS ON STRUCTURES LOCATED  
IN UPPER SILESIA COAL BASIN – SELECTED EXAMPLES**

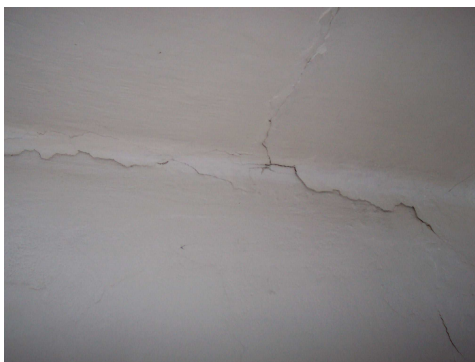
Several horizontal and diagonal cracks in the external and internal walls in a detached house were detected, as well as in the cellar floor. Furthermore, the house is tilted, which may be a result of not only mining works but also of ground movements of the escarpment on which it is situated. The most visible cracks and fissures are shown in the photographs below. It may be definitely assumed that the technical condition of the building is bad.

Fig.1: Cracks in the ground floor walls

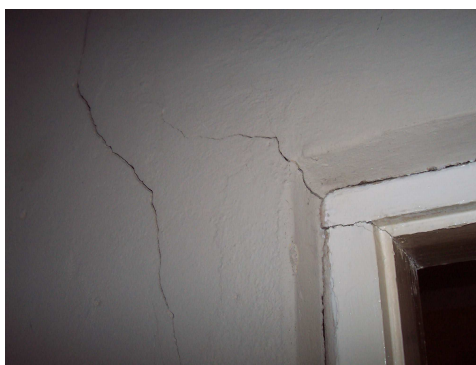
Fig.2: Cracks in the walls at the door opening

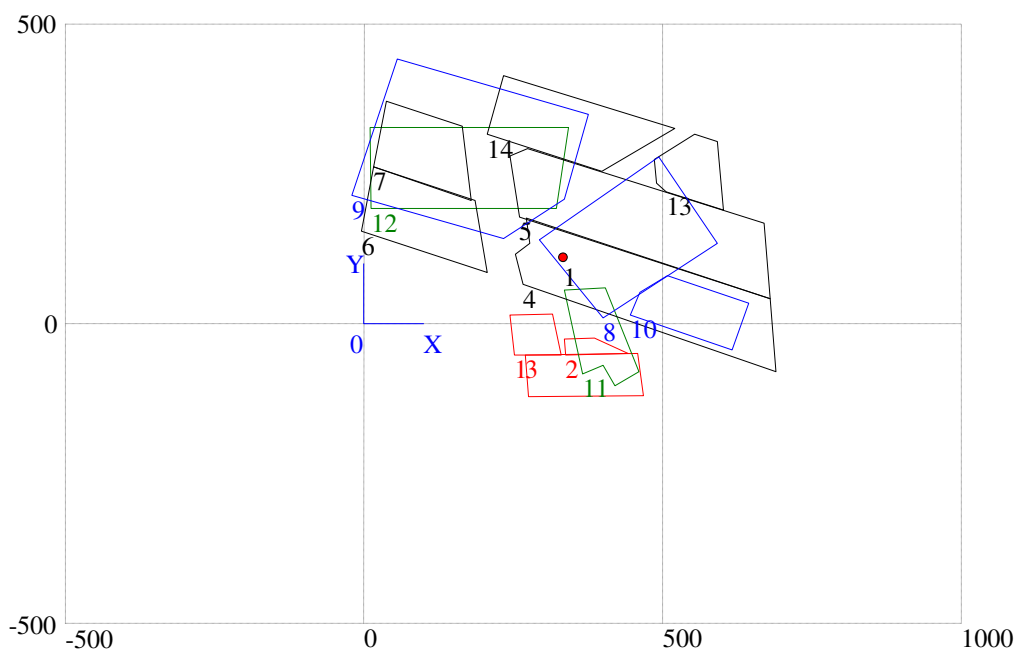
Fig.3: The location of the excavated sites as related to the examined house.

The numbers of the sites shown in the Figure correspond to the numbers stipulated in Table 1.  
The house is marked by the red circle.

As seen in the above Table, the examined house was subjected to the impacts of land subsidence of the values about 1.07 m, the tilt of the second category and the third category of horizontal displacement. The values of the deformation indices could have been higher in view of the reactivation of old shallow gobs.

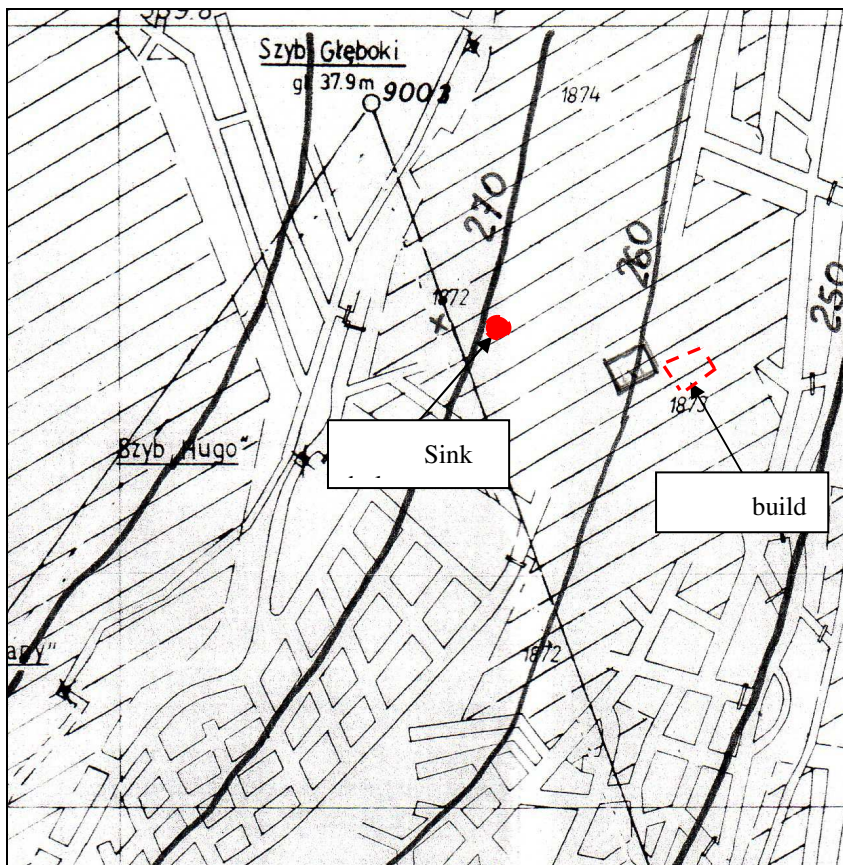
In 2006 at the distance of about 50 m from the house there occurred land subsidence with the dimensions of 3.5m x 5.0 m and the depth of 3.0 m. In February 2006 a specialised company conducted geo-physical tests by means of the electro-resistance method, the measurements were taken at 5 m x 5 m in the area of 50 m x 110 m. Low and high-values of resistance anomalies were detected. The low resistance value anomalies involved the infiltration of water or sewage from the rock mass to unsealed pipelines. The high resistance value anomalies point to the presence of cracks and crevices, and, in the extreme points, to the presence of voids. The tests were carried out by means of two measurement systems at the depth range of about 20 to 30 m. It should be emphasised that the above mentioned subsidence emerged at the range of minimal anomaly range of about 10 izo-oms.

Fig. 4: The map of coal seam 207

In the next phase ground soil treatment works were conducted. 30.55 m<sup>3</sup> to 457.71 m<sup>3</sup> of fill was put into 10 drilled holes. In the course of the conducted works the previously filled subsidence trough was activated. The voids in two holes were detected: (at the depth of 25-25.5 m and 28 – 30 m, and the height up to 0.5 m). Numerous zones of cracks were detected at the depths of: 30 m, 31 m and 32 m.

A volume of 189.89 m<sup>3</sup> to 1041.06m<sup>3</sup> of fill was placed in further 8 holes. The works were conducted until the capacity (absorptive power) of the holes was used up. Control geo-physical tests proved that the rock mass was sealed. Successive tests (conducted by means of the gravimetrical method proved the occurrence of anomalies in three areas, which may prove the presence of the voids in the rock mass.

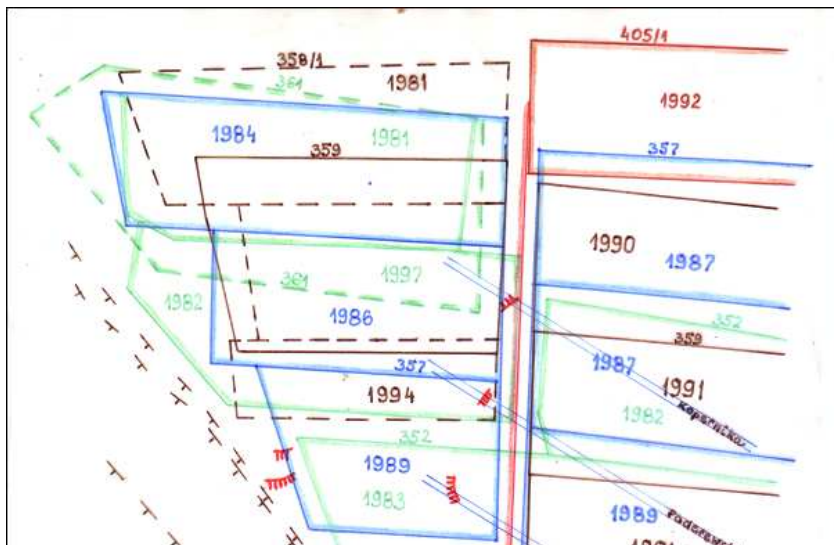
The deformations occurring in the south-eastern part of the discussed area involved the fault zone and the edges of the extraction zones of seams: 352, 357, 359. The deformations occurring in the central part of the area stem from the divergence of the mining extraction impacts evoked in seams: 352, 357, 358/1, 359, 361.

In the discussed examples the reasons for the occurrence of the deformations have been associated with the convergence of the mining extraction carried out in the mentioned seams and the existence of the fault in the south-eastern part of the area. Surprisingly, it should be emphasised that at the time of the occurrence of the deformations, no mining works were conducted in the discussed area.

Fig.5: Location of the mining excavation works in relation to the geological faults
